# Federal Clean Water Section 319 Grant

## Sebewaing River Watershed Alternative Cropping Practices Project

Project Fact Sheet

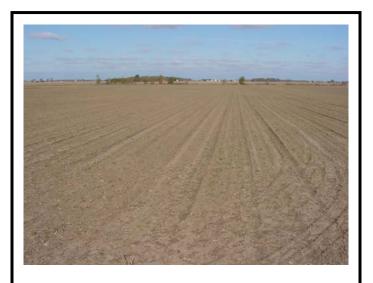
### McNeil Tillage Demonstration Site Before:

A typical sugar beet field after harvest within the Sebewaing River Watershed is left with no residue to protect the soil from wind and water erosion over the winter months. This site has drains on three sides.

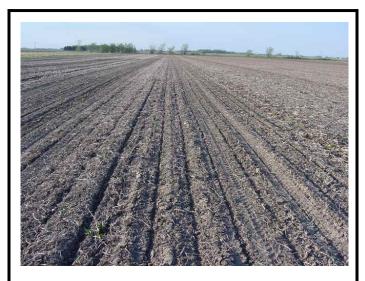
#### McNeil Tillage Demonstration Site After:

Randomized and Replicated Strips have been established on this site to compare convention and zone tillage. Photo shows corn stalk residue left over winter to provide protection. Zone built strips have been installed and in the spring planting will be done directly over these slots without additional tillage.

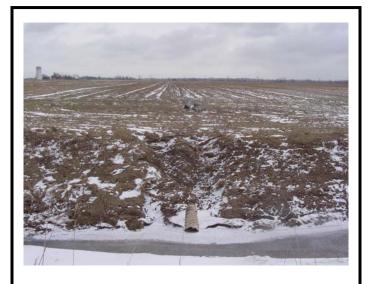
A typical fall plowed field within the watershed. This field is prone to wind and water erosion. The proximity to the drain leads to sediment and nutrient loading.

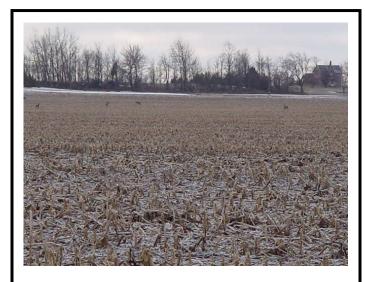
Corn stalk residue left over winter reduces wind and water erosion and sediment and nutrient deposition. Corn stalks also provide wildlife cover and a winter food source.
